Post-Disaster Rescue Archaeological Investigations, Evaluations and Interpretations in the Kathmandu Valley World Heritage Property (Nepal): Observations and Recommendations from a UNESCO mission in 2015

Coningham, R.A.E.¹, Acharya, K.P.², Davis, C.E.¹, Kunwar, R.B.³, Tremblay, J.C.¹, Schmidt, A.¹, Simpson, I.⁴ and LaFortune-Bernard, A.¹

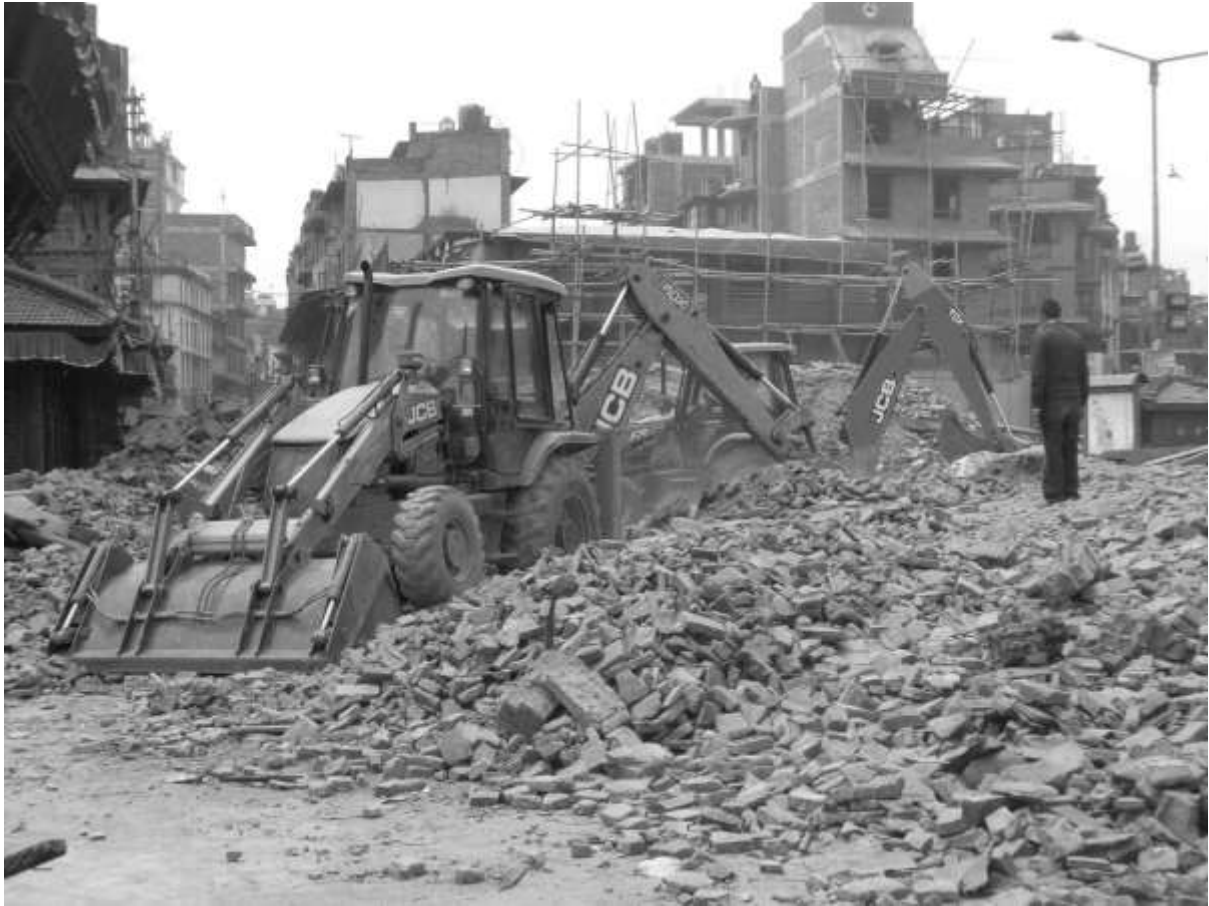
Figure 2: JCBs clearing the debris at Kathmandu on the 26th April 2015 (Image courtesy of Kai Weise).

Observers noted that the army dispatched a bulldozer within the first hour of the collapse to assist with the recovery and that two JCBs had been deployed to the site the following day as the recovery efforts continued (Figure 2). During these two days, the outer foundation walls of the Kasthamandap on the south, southwest and southeast were destroyed and the inner walls damaged along with large portions of the monument's tile pavement. Temporary shelters were then erected by nearby residents on the levelled mound of debris and, at a later stage, a dry brick wall on the south, southwest and southeast sides of the Kasthamandap was constructed in order to retain the loose brickbat, tile and clay debris above the ruins. Timbers from the site were removed with two of its major pillars and one of its cross-beams being placed under a tarpaulin beside the eastern side of the Navadurga Temple. The location of the other two major pillars remains unknown. The two main broken parts of the image of Gorahknath were removed from the site, with one portion stored within the

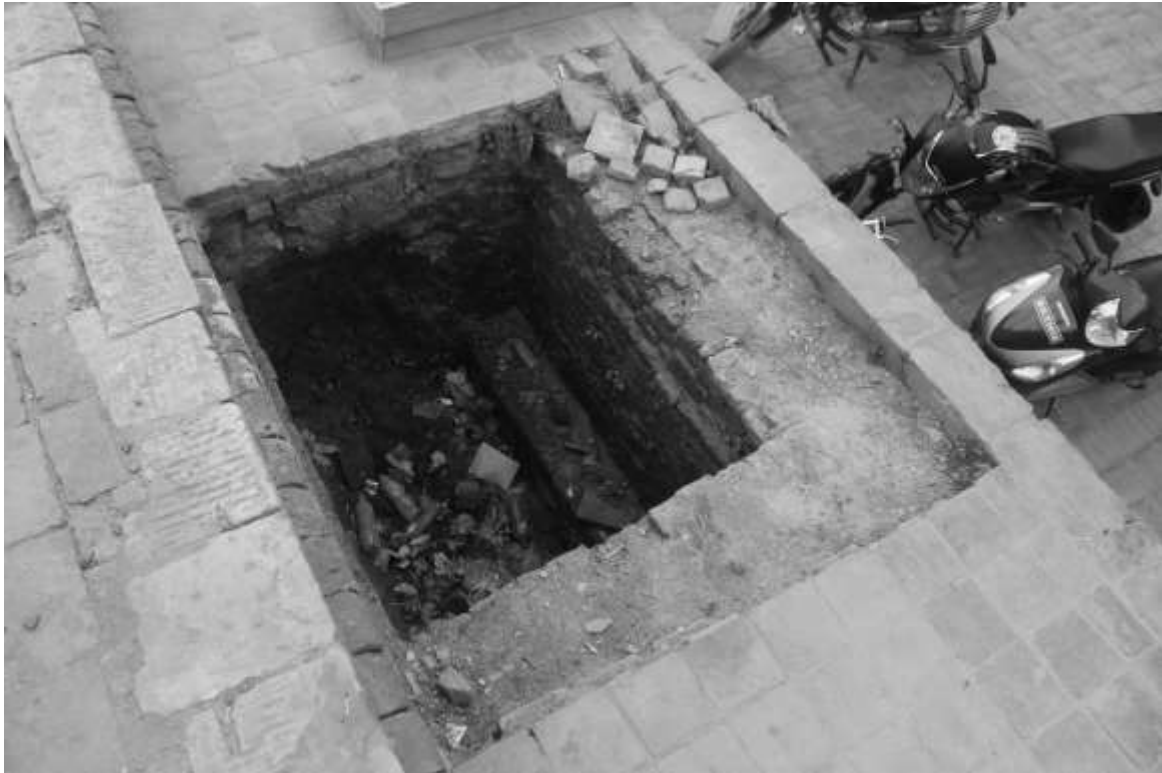
Figure 3: One of the unrecorded trenches opened on behalf of KVPT located on the lower plinth on the west of the Char Narayan Temple. Photographed in October 2015.

the north-east and south-west bore holes contained redeposited packing materials. At the site water table seepage was recorded at a depth of five metres in the boreholes (ibid.: 7). Amongst the study conclusions, two of the more relevant notes stated that “no more archaeological ruins are found beyond 1.5m depths” and that “only brick bats and sandy silts could be seen upto (sic) the existing foundation depth” (ibid.: 14). This unpublished technical report, which was dated July 2015, only reported on the results of the bore holes. The report did not refer to the cutting of the trenches into the Char Narayan Temple platform, although we understand that these were also commissioned by the KVPT. It is apparent that this historic monument was damaged during this process and that no attempt was made to record the archaeological materials recovered or encountered and no sieving of the extracted soils. At the time of our mission, these trenches were still open, presenting an additional danger to the fragile wall foundations thus exposed (Figure 3). It was one of our recommendations that the trenches should be backfilled as soon as possible.

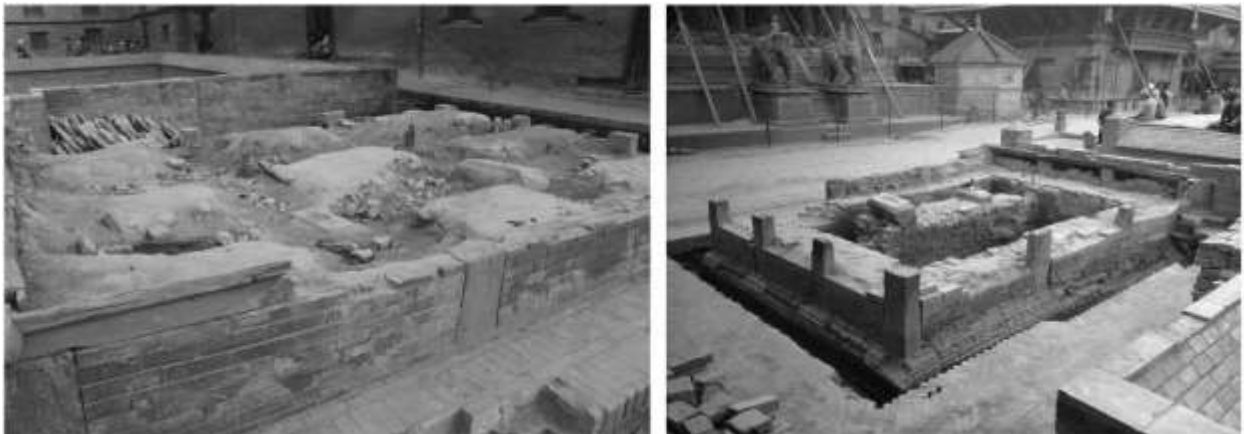
Figure 4: The collapsed Mani Mandapa in Patan, photographed in October 2015 (left) and May 2016 (right) illustrating unrecorded excavation of the foundations.

Furthermore, between the submission of our recommendations report to UNESCO and the Department of Archaeology in December 2015 and a site visit to Patan in May 2016, we noted that the foundations of the Mani Mandapa had been intrusively dug into (Figure 4). This intrusive activity had removed paving around the base of the brickwork of the monument that stood above the current pavement level and had also dug out the soil fill around the brickwork of the foundations. This soil fill had survived the collapse of the monument during the earthquake of 2015 and was not at risk, but the undocumented digging has now led to the loss of archaeological information and the destruction of subsurface heritage. We again stress the need to protect collapsed monuments and their foundations from unchecked and unrecorded interventions, and to ensure that such remains are not left open and susceptible to further damage.

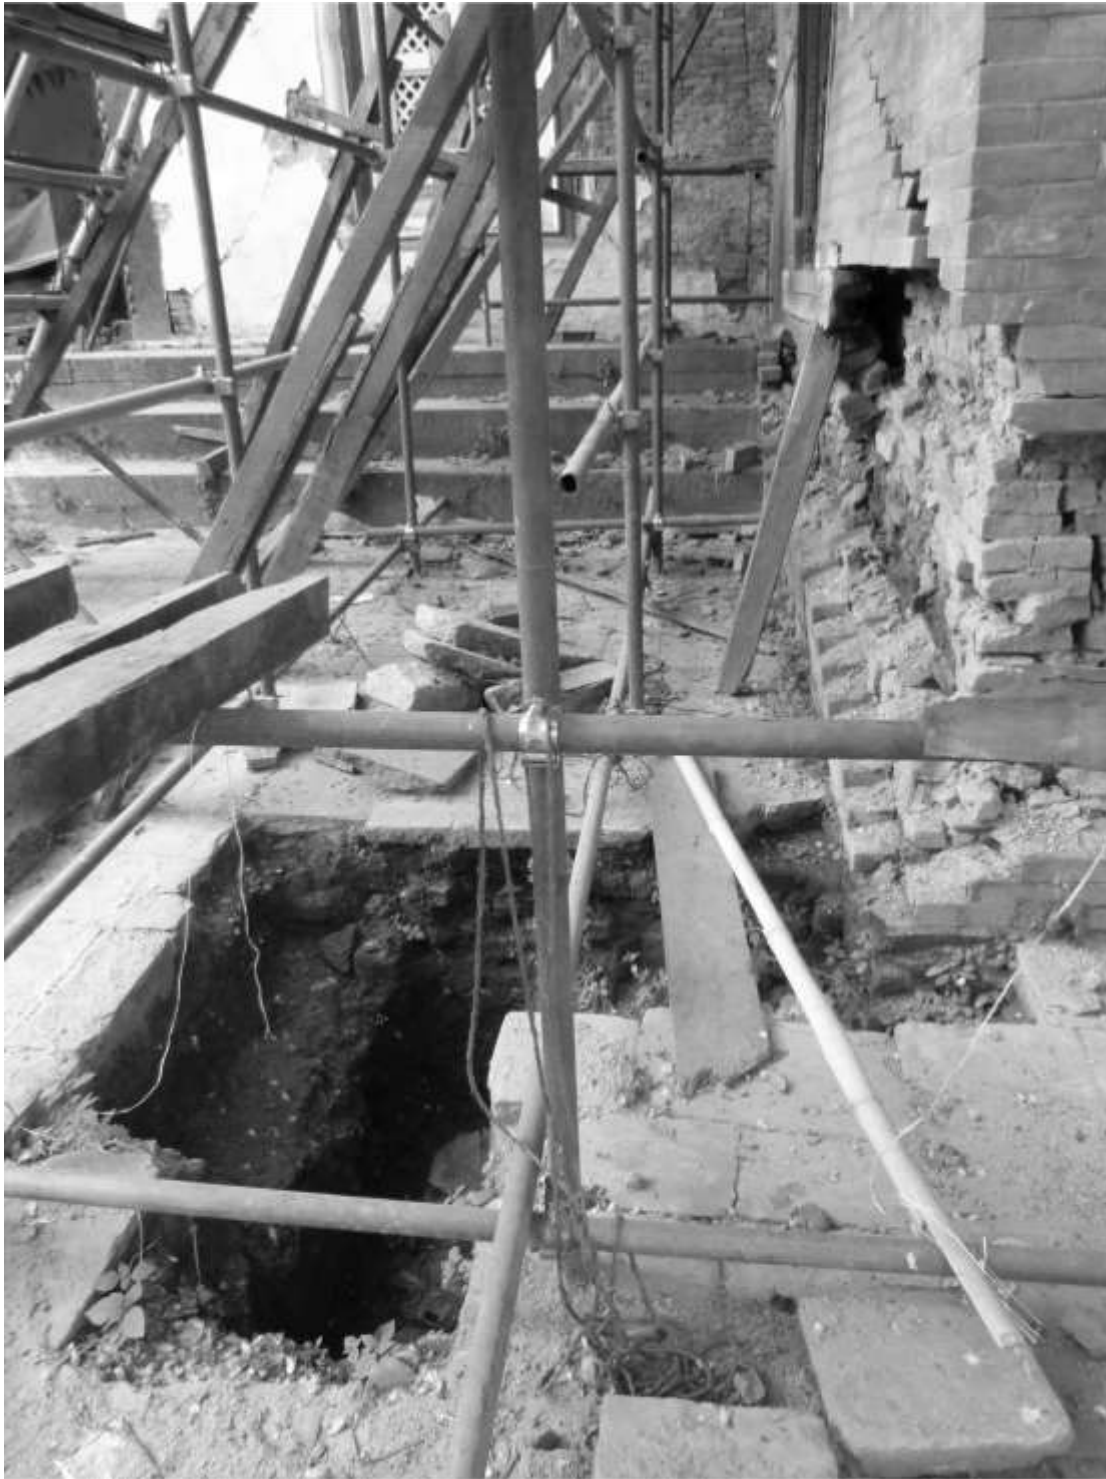
Figure 5: Unrecorded excavation trench cut alongside north facing wall of the Degutale Temple in Hanuman Dhoka Durbar Square. Photographed in October 2015.

The interventions in Patan were not the only unrecorded exploratory excavations within the Kathmandu Valley World Heritage Site as we were also able to observe a trench cut alongside north facing wall of the Degutale Temple in Hanuman Dhoka Durbar Square. Measuring approximately two by one metres, the trench was cut below an area where a portion of the outer brick facing of the Temple had collapsed. Cut by workmen on the instructions of the Engineering Section of the Department of Archaeology soon after the earthquake, no plans or sections were recorded at the site and no report of the findings submitted to the Archaeology Section of the Department of Archaeology. Although access was restricted by the scaffolding and shoring above, the one metre deep section demonstrated the presence of subsurface archaeology. At the time of our mission, it was noticeable that the trench was still open, presenting an additional danger to the fragile wall foundation thus exposed (Figure 5). As with the open trenches of the Char Narayan Temple, we recommended that this trench should be backfilled as soon as possible.

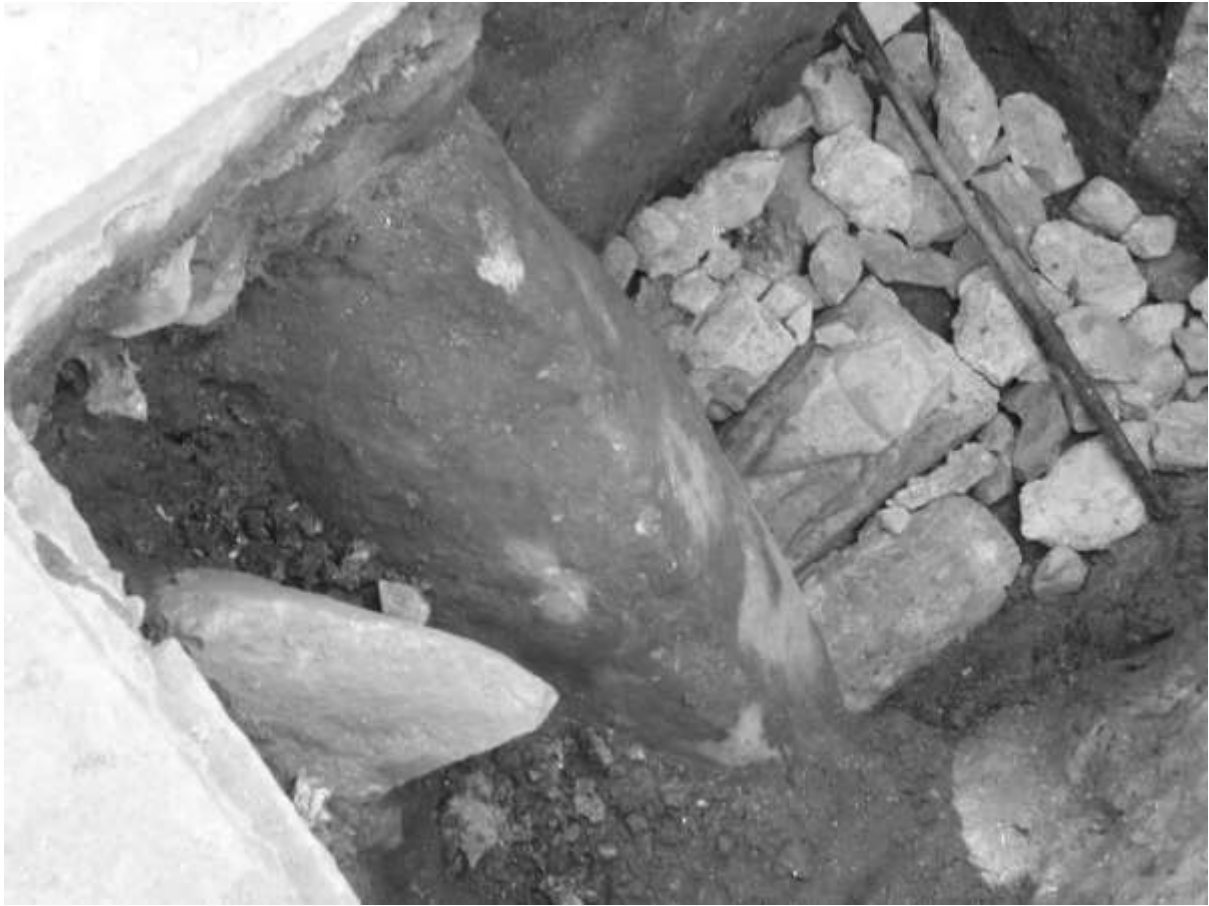
Figure 6: Unrecorded cut adjacent to a temple platform in Hanuman Dhoka Durbar Square for the installation of a lamppost.

The second intervention was associated with the erection of new solar lights within the Durbar Square. In one of the observed cases, workmen from the Municipality cut a trench measuring two by one metres through the brick pavement of the Square adjacent to one of the historic monuments. Despite encountering a large stone slab and brick within the metre deep trench, the workmen completed their work without archaeological supervision or recording of the subsurface archaeology, inserted the new lamp and concreted it in place (Figure 6). Note should also be made of the movement of traffic within two of the main Durbar Squares, Hanuman Dhoka and Bhaktapur. Whilst in Bhaktapur, the Durbar Square was opened to traffic to due to debris blocking routes through the city elsewhere, and although the effect of the vibrations from traffic is uncertain, it is unwise to allow heavy vehicles pass close to a number of the fragile surrounding monuments, many of which are supported with timber struts. Such traffic, which includes heavy water trucks should be controlled and, wherever possible, stopped until the buildings are consolidated (Figure 7).

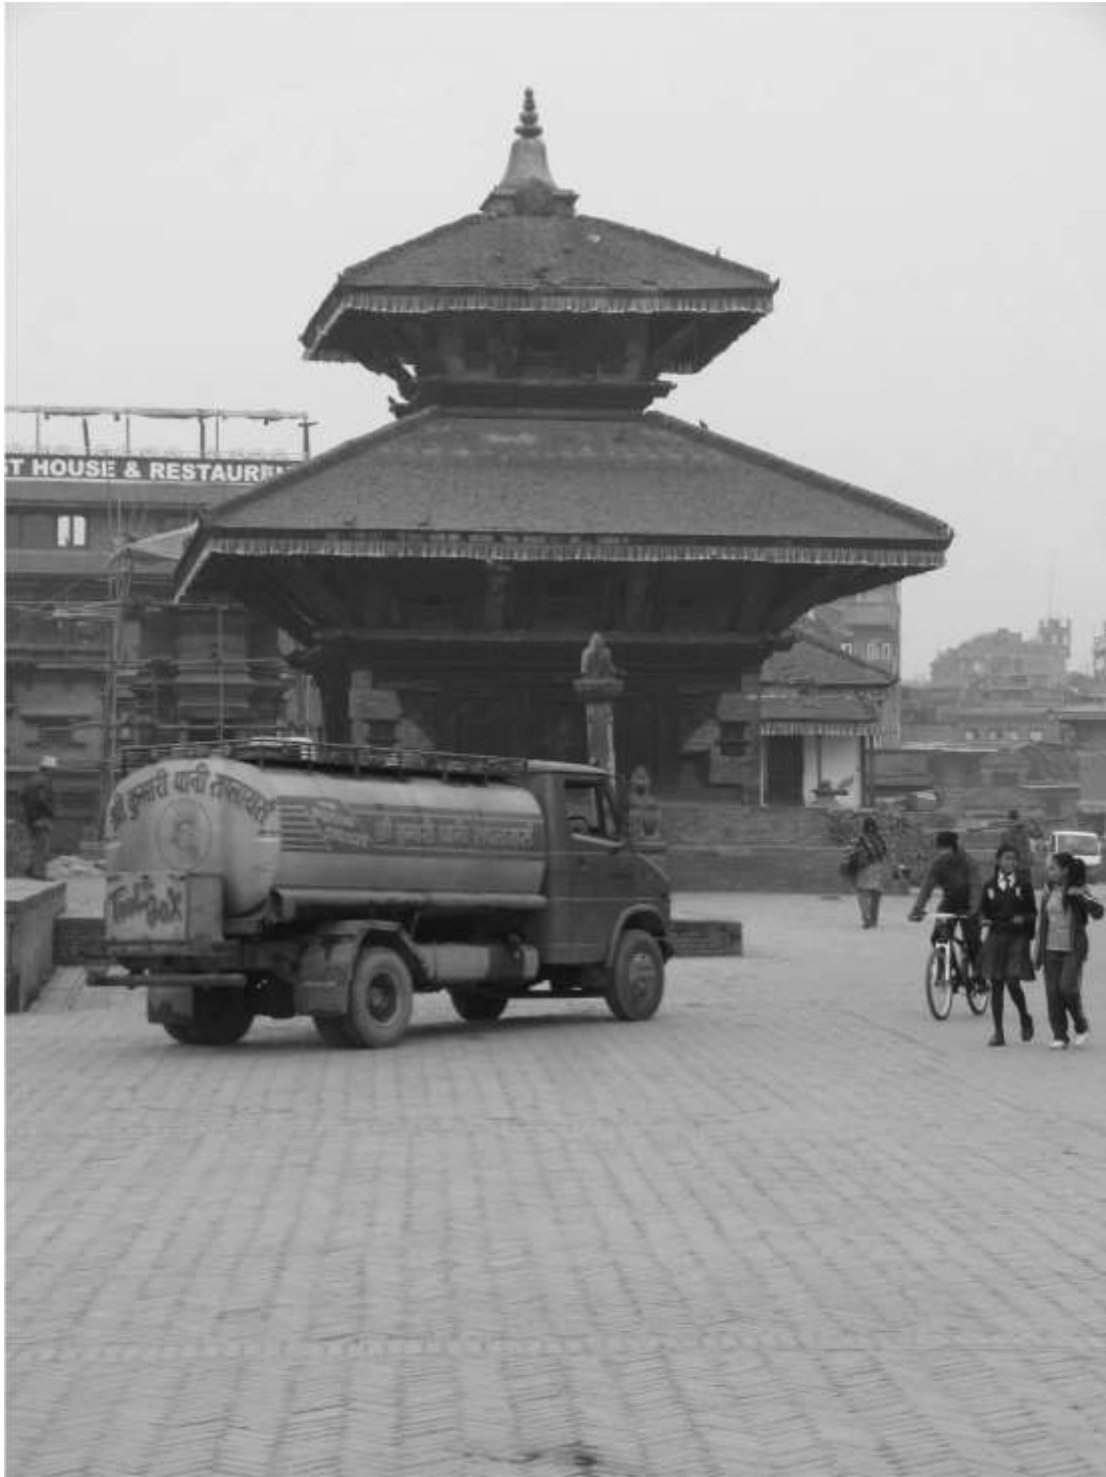
Figure 7: Heavy vehicle passing through the main Durbar Square at Bhaktapur. Photographed in October 2015.

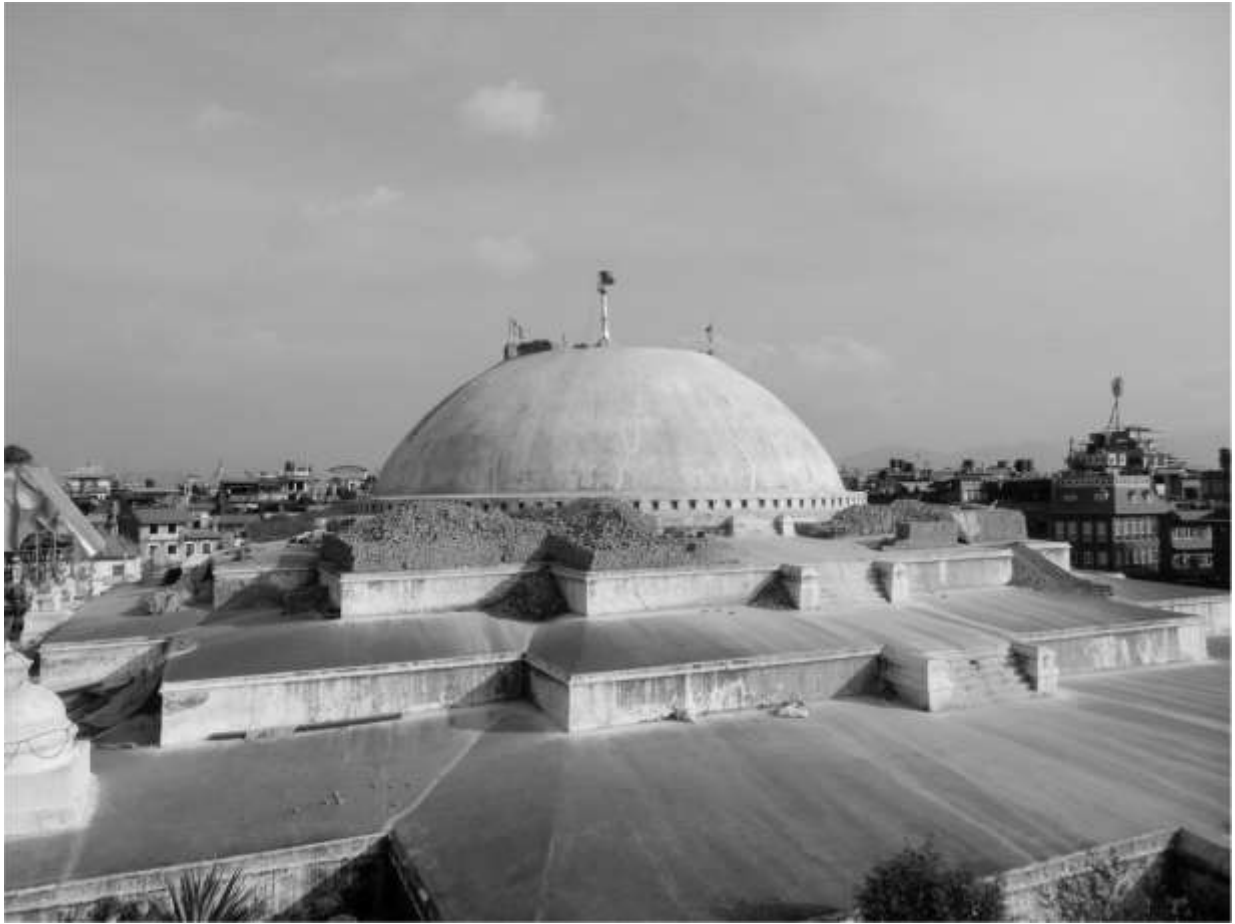
Figure 8: Image of the Baudhnath Mahacaitya after the unrecorded removal of the brick tower. Photographed in November 2015 (Image Courtesy of Mildred Davis)

We are at present unable to evaluate the nature of this intervention or its findings as the Department of Archaeology had not been provided with detailed technical reports of the intervention in May 2015, whilst the activity report of May 2015 states that “Considering the short time allowed by the coming of the monsoon, we decided to start excavating it without drawings. Instead pictures are taken when relevant elements are found” (Andolfatto 2015: 1). Our mission recommended that no further interventions are undertaken prior to the submission of a detailed technical report of this emergency activity, especially archaeological activities that are not designed for the evaluation of damaged structures and subsurface heritage prior to reconstruction. Finally, reference should also be made to the recent dismantling of the entire brick tower of the Bauddhnath Mahachaitya in November 2015 (Weise 2015: 43). Although not related to subsurface heritage, this process was undertaken by the Bauddhnath Area Development Committee without detailed recording of construction and materials from within the tower was dispersed to pilgrims with no degree of research recording undertaken (Figure 8).
