Scarre, Chris (2006) 'Consolidation, reconstruction and the interpretation of megalithic monuments.', *Arkeos*, 16 . pp. 13-44.

# CONSOLIDATION, RECONSTRUCTION AND THE INTERPRETATION OF MEGALITHIC MONUMENTS

CHRIS SCARRE

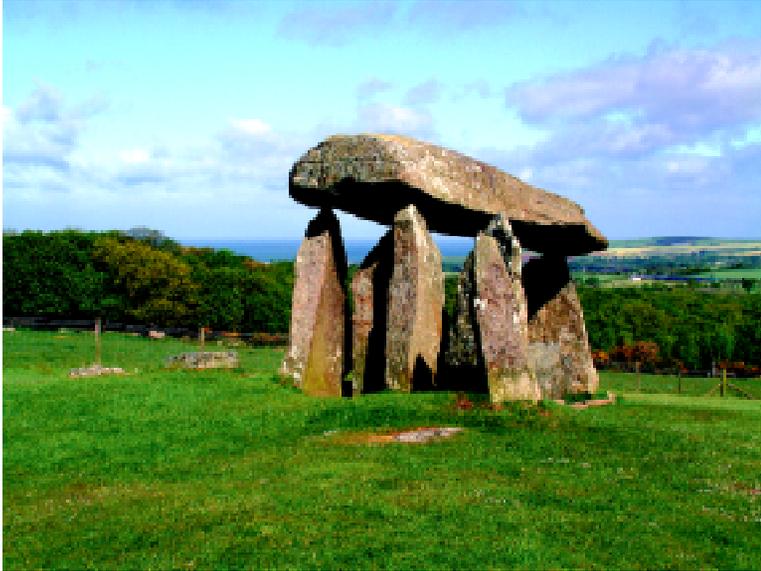
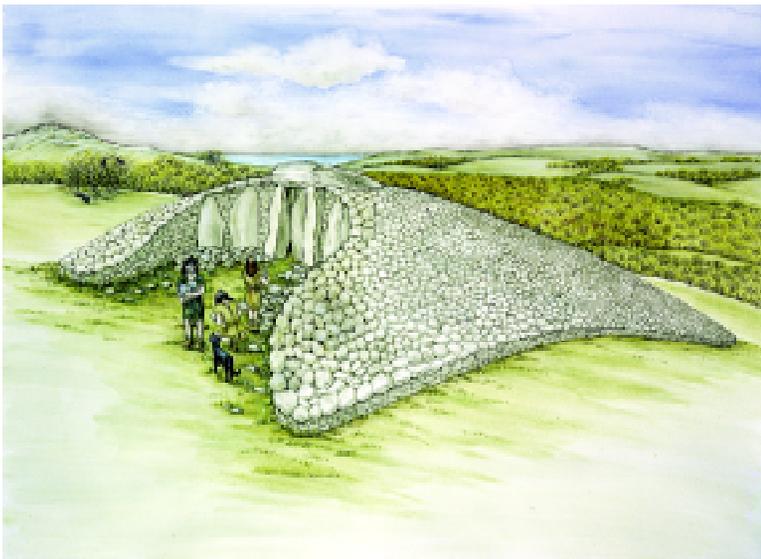
**FIG. 2.** Pentre Ifan: (above) photo of site at present day (photo: Chris Scarre); (below) reconstruction drawing (by Jane Durrant) showing the monument with a hypothetical covering cairn reaching up to the level of the capstone (Cadw: Crown Copyright).

The problem can be highlighted by considering one particular type of megalithic tomb where (despite the prevailing orthodoxy) the nature of the covering mound or cairn is still disputed: the portal dolmens of southwest Britain. The famous Pentre Ifan overlooking Cardigan Bay in Pembrokeshire is an excellent example of this type. The surviving structure consists of a rectangular megalithic chamber formed of a massive capstone resting on three uprights, with a further slab set vertically between the twin pillars of the 'portal' and remains of a curving façade of orthostats to either side (Fig. 2). The romantic setting and the striking appearance of Pentre Ifan have long attracted the attention of visitors. It was the subject of one of the earliest surviving descriptions of a Welsh megalithic monument in George Owen's "Description of Penbrookshire in General" of 1603. A famous lithograph of 1865 shows mounted horsemen sheltering beneath the great capstone.

At the end of his excavations Grimes wrote to the Ministry of Works proposing that the cairn of Pentre Ifan be ‘partly restored’: “A low mound could mark the actual limit [of the cairn], with a steeper rise a few feet from the capstone” (quoted in Turner 1992, 107). The reply from the Inspector of Ancient Monuments for Wales, B.H.St.J. O’Neil, was cautious: “whether or not I should like to replace any of the mound I have not yet decided. We know that there was one, of course, but I think that we should also remember that Pentre Ifan is the most impressive of its kind in Wales and one of the finest in Britain. Are we then justified in the cause of pure science in detracting from its outward impressiveness?” (quoted in Turner 1992, 108).

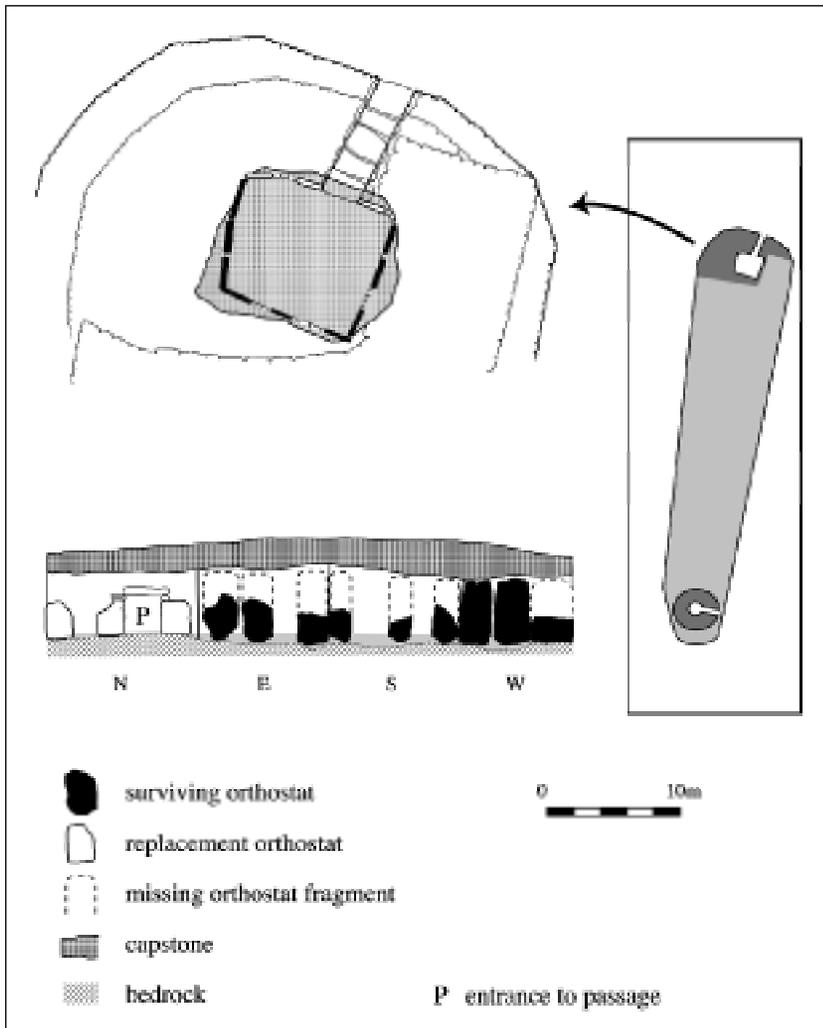
**FIG. 3.** Bougon: the reconstruction of Chamber F2: plan and internal elevations of chamber showing (black) the surviving orthostats; (broken outline) their missing upper portions; and (white) the replacement orthostats added during the consolidation and reconstruction work of the 1970s (after Mohen & Scarre 2002).

Tumulus F provides a good example of the kind of work that was undertaken (Mohen & Scarre 2002, 225-231). Visitors in the early 19th century remarked the exposed capstone that was visible at the northern end of the mound (Chamber F2) and in 1840 three local antiquarians undertook excavations beneath one edge of the slab. They uncovered three of the orthostats of the chamber beneath, and recovered a small quantity of archaeological material. The following year (1841) the local landowner decided he would search for the “treasure” within the chamber himself, but in digging around the bases of the orthostats he caused the massive 32-tonne capstone to collapse. There it remained throughout the rest of the 19th century and into the 20th century. One of the first objectives of the consolidation work of the 1970s was to restore Chamber F2, lifting off the capstone, straightening the orthostats, providing new ones for those that were irreparably crushed, and finally replacing the capstone and building up the whole of this end of the mound, to recreate what was thought to have been its original appearance (Fig. 3). Thus a large part of the present structure, including three whole orthostats on the northern side of the chamber interior, is a 20th century rebuild.

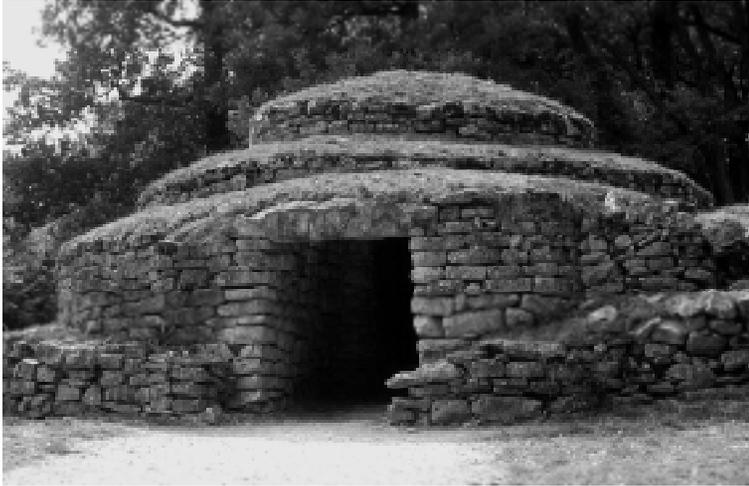
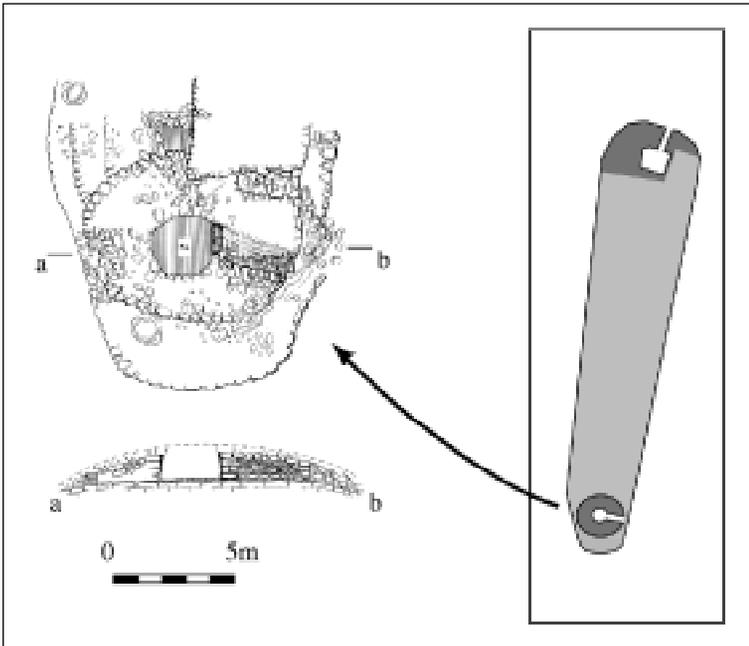
**FIG. 4.** Bougon: the reconstruction of Chamber F0: (above) photo of the reconstructed monument (photo: Chris Scarre); (below) plan and cross-section showing the surviving extent of the original structures (after Mohen & Scarre 2002).

The excavation of Tumulus F not only revealed the internal structures of the cairn but also led to discovery of a small circular chamber of dry-stone construction at its southern terminal. This chamber (Chamber F0) was badly degraded and had no trace of a capstone. It was concluded that it had been covered by a corbelled vault. Corbelled vaults are a common feature of Neolithic chambered tombs in Normandy, Brittany and Poitou-Charentes, and there is nothing inherently improbable in that conclusion. Once the excavation of Chamber F0 was completed, reconstruction of the monument was undertaken, and a covering cairn was added. The published excavation diagrams show that the chamber walls were preserved in their original state to a height of only around 1 metre, which means that the greater part of the structure visible today dates from the 20<sup>th</sup> century AD rather than the 5<sup>th</sup> millennium BC (Fig. 4). Yet although much of Tumulus F is now effectively modern, the work undertaken at this and other of the Bougon mounds serves to highlight the substantial dimensions and impressive appearance of these Neolithic monuments. Equipped with information boards and an

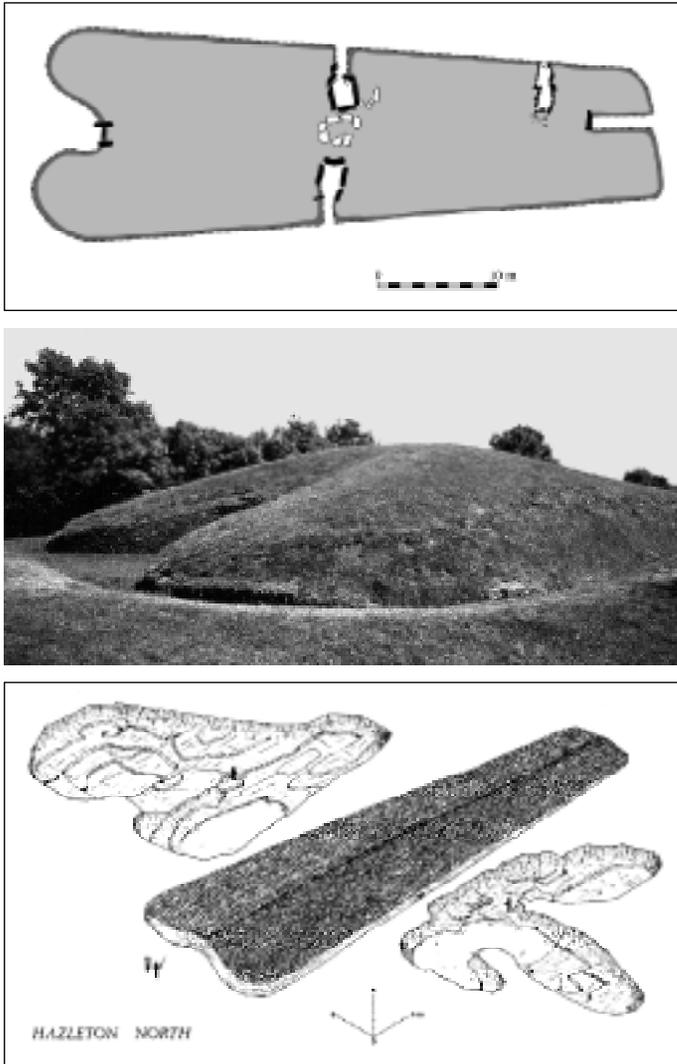
**FIG. 5.** Belas Knap: (above) plan of the monument showing the lateral chambers and the niche with 'false door' at the broader eastern end; (middle) photo of the monument at present day, following consolidation work undertaken during the 1930s; (below) reconstruction drawing (by Jon Hoyle) of Hazleton North, giving an impression of the likely original appearance of Belas Knap (by kind permission of Alan Saville).

The Belas Knap that the visitor encounters today is a neat grass-covered dome edged by tidy dry-stone walling (Fig. 5). The walling of the mound is in fact very similar to the field wall that was built around the site in the 1860s. The setting is emphatically rural, not to say bucolic, with woodland and ploughed fields, and the nearest road over half a mile away. The visitor might very easily get the impression that Belas Knap is effectively an intact monument, and that this is how it must originally have looked in the 4<sup>th</sup> millennium BC.

had been placed against the outer wall as a kind of revetment, but closer observation led to an entirely different conclusion. The excavators noticed that the slabs had a bevelled and water-worn edge on one or two, or occasionally on three sides; and furthermore that many of them had a white watermark about 3cms from the actual edge, as if they had been laid in overlapping fashion one upon the other. It became obvious that these had been the roofing or covering of the mound (Berry 1930, 129-131). The precise morphology of the roof remains somewhat conjectural, though a ridged form, resembling that of a house, has been proposed for Cotswold-Severn cairns of this type (Corcoran 1969, 78). Such a roof would have given Belas Knap a similar appearance to that recently reconstructed on paper for the neighbouring Cotswold-Severn mound of Hazleton North (Saville 1990; Fig. 5).

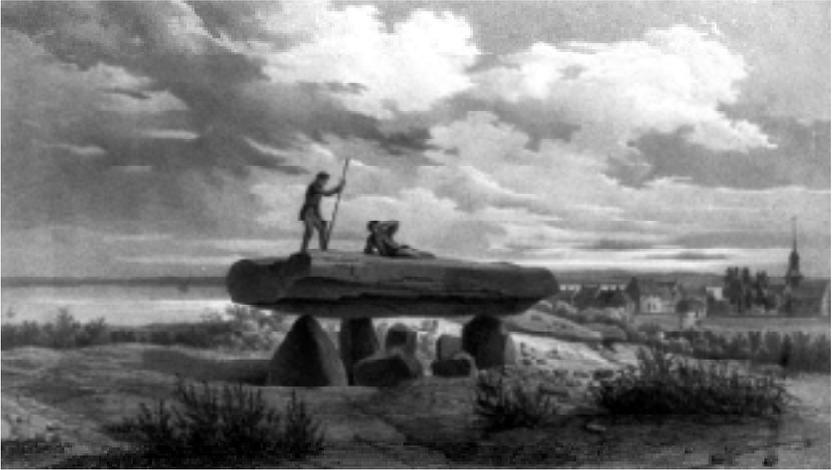
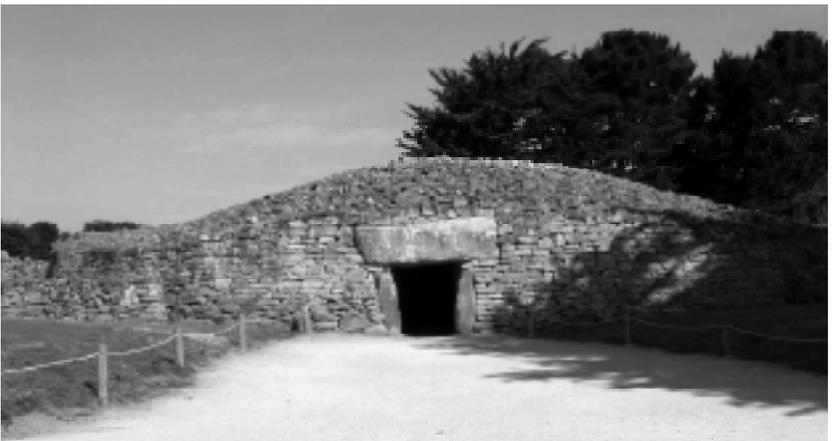
**FIG. 6.** La Table des Marchand: (above) engraving from a drawing of 1823 by J.B.J. Jorand; (below) photo of the reconstructed cairn in 2004 (photo: Chris Scarre).

Belas Knap is an example of the 'first degree', where the primary aim is consolidation. The 'second degree' goes beyond this to engage in a much more overt process of reconstruction. Here the passage grave of La Table des Marchand at Locmariaquer in southern Brittany provides a good example. The contrast between the condition of the monument illustrated in early 19<sup>th</sup> century engravings and at the present day is particularly striking (Fig. 6). Today the megalithic chamber is enclosed within

This latest reconstruction both protects the megalithic chamber and gives an idea of the original appearance of the monument (Fig. 6). Whether it has enhanced the visitor-experience of La Table des Marchand depends perhaps on those visitors' expectations. A recent survey revealed that some people regret the conversion of what was a romantic ruin into the present neat and tidy cairn. The reconstruction of the cairn has also masked key features of the monument that were formerly more easily visible, including the fact that the capstone was a fragment of a larger menhir that had been broken and dragged here for re-use. It has also made it impossible to see the carvings on the rear face of the backstone of the chamber. These, first discovered in 1922, demonstrate that this stone was originally a free-standing decorated menhir since it was decorated not only on its front, facing into the chamber, but also on its back, which would have been hidden once the enclosing cairn was built (Péquart *et al.* 1927, 122; Breuil *et al.* 1938, 19-20. It is possible, indeed, that the chamber was constructed around this pre-existing standing stone (L'Helgouach 1983, 65; Le Roux 1984, 242). Thus one inevitable consequence of the reconstruction work undertaken at La Table des Marchand has been to obscure the earlier phases in the development of the monument. The structure is reconstructed as it would have appeared in its final state. Yet it is unwise to be too critical, and this loss is perhaps a small price to pay for the better preservation of the chamber, enclosed within its new protective mound. It reminds us once again, however, that reconstruction is never a neutral process.
